**RESPONSE TO DEBTORS' SECOND OMNIBUS  
OBJECTION TO CLAIMS (NON-SUBSTANTIVE)**

**LIBBY ASBESTOS PROJECT**  
**Contaminant Screening Study**  
**Primary Structure and Property Assessment Information Field Form (Primary IFF)**

Field Logbook No.: 100234 Page No.: 80 Site Visit Date: 6-30-03  
 Address: 3819 Hwy 2 S. Structure Description: House  
 Occupant: DOUG + MARILYN KEELEY Phone Number: 293-5063  
 Owner (if different than occupant): N/A Phone Number: \_\_\_\_\_  
 Business Name: N/A  
 Sampling Team: JOE MARTIN, DAVE SPIELMAN  
 Field Form Check Completed by (100% of forms): [Signature] Joe Martin  
 Screening Field Check Completed by (2% of forms): \_\_\_\_\_

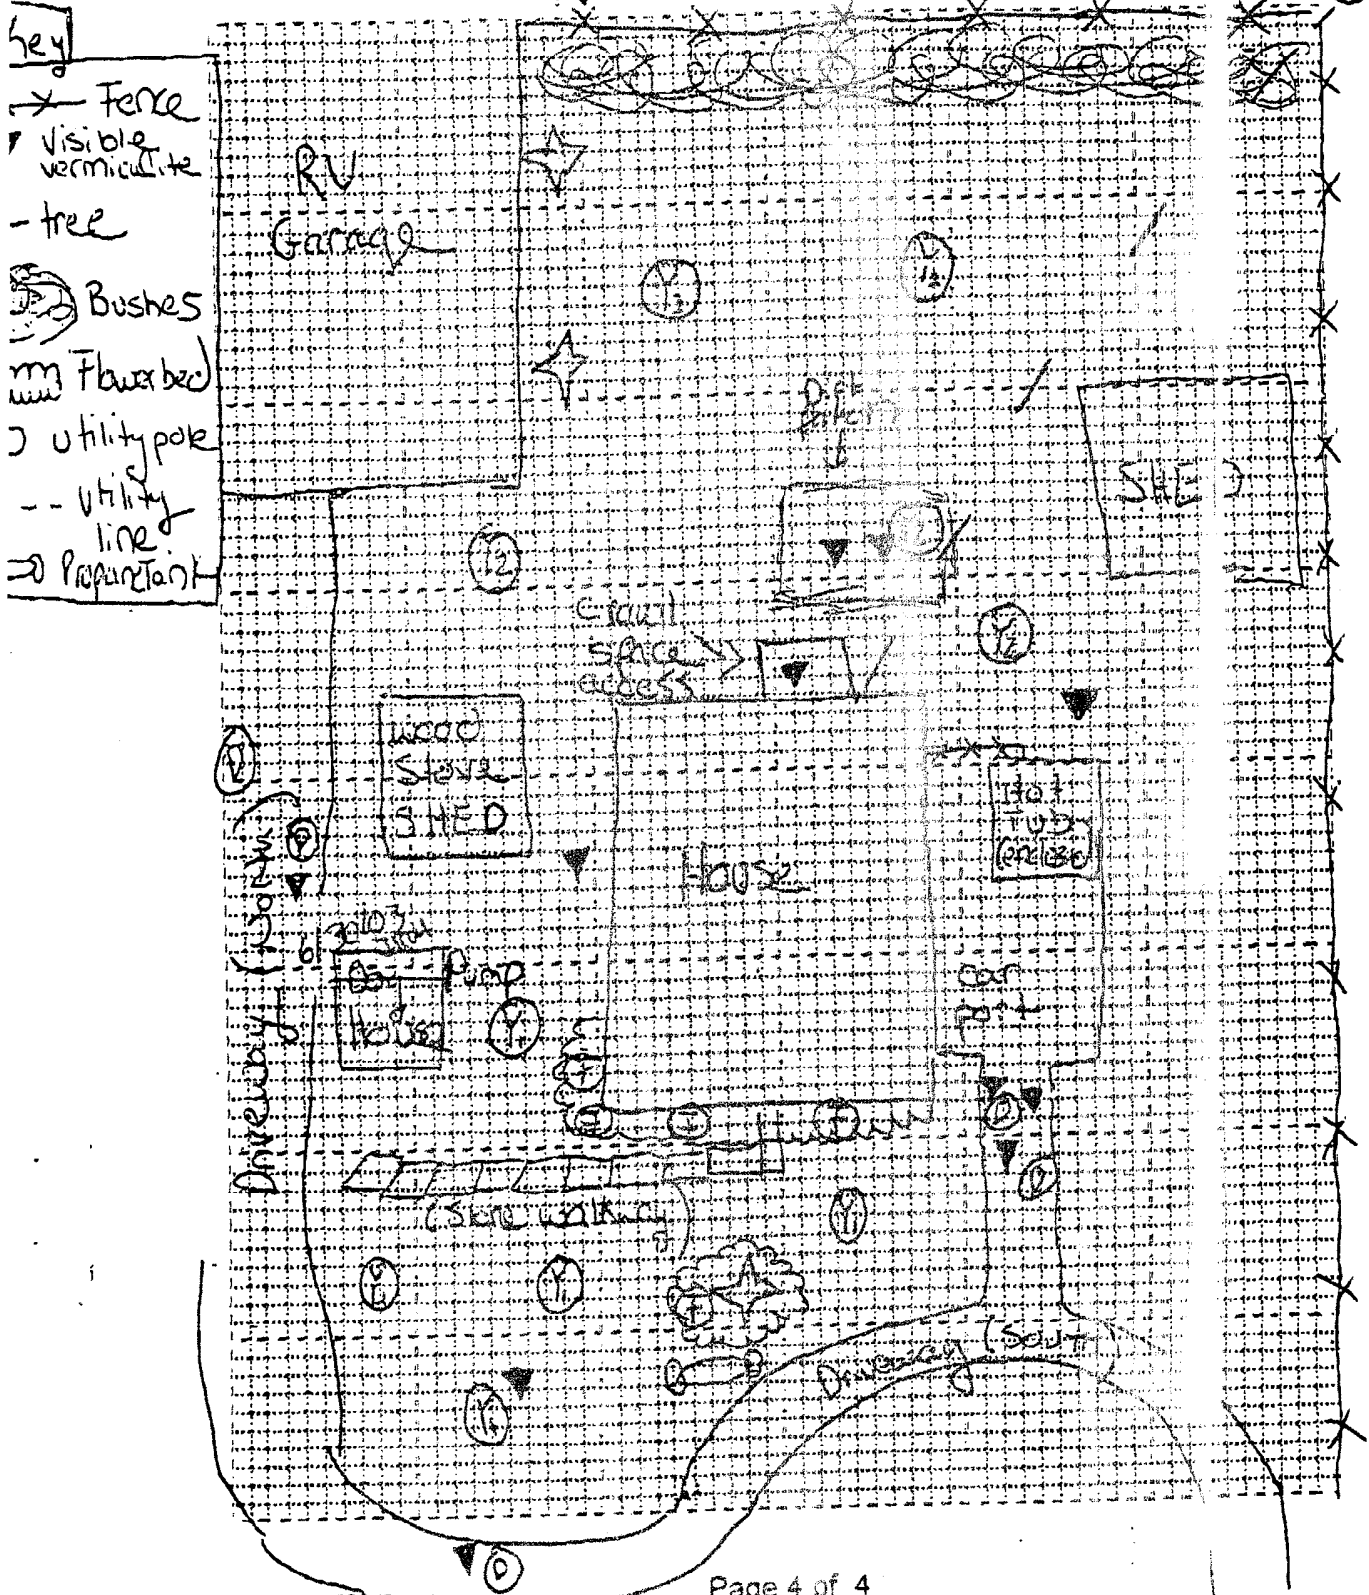
### FIELD DIAGRAM OF PROPERTY

Data Item	Value	Notes
Location of indoor vermiculite (circle all that apply)	Attic Walls <u>Crawl Space</u> None Visual in Living Space: Basement, Ground Floor, Second Floor, Attached Garage Other: _____	If in living space, provide specific location:  vermiculite visible in crawl space access soil
Outdoor Information		<input checked="" type="checkbox"/> Outdoor Visual Inspection Complete: <u>DS JM 6-30-03</u>
Location of outdoor vermiculite (circle all that apply)	<u>Driveway</u> Flowerbed Garden <u>Yard</u> Former Flowerbed Former Garden <u>DS JM 6-30-03</u> Stockpile None Other: _____	2 driveways visible in driveway area. Both. Vermiculite visible in back yard, south side of house. High concentration.
Overall Assessment Complete: <u>DS JM 6-30-03</u>	<input checked="" type="checkbox"/> Reconnaissance (Verbal Interview, Indoor, Outdoor Inspection)	
Are primary source materials present at the property?	<u>Yes</u> No

Where are primary source materials located?	Inside <u>Outside</u> <u>DS JM 7-10-03</u> <u>Both</u> <u>DS JM 7-10-03</u> NA	NA applies if no primary source materials are located at the property.
ADDITIONAL INFORMATION (Note any partial access or sample collection issues)		
① Wood stove is in a separate shed ("stove house," w/ stove shed) uses a duct to the house for ducted heating		
② Original structure on site was demolished in 1993, new house built by same owner/occupant (Doug Kelley) - Mr Kelley reports that original structure had zonalite insulation, new structure does not, (confirmed by owner reports some lumber from original structure was reused in the new house.		
③ Area with visible vermic. in south back yard (marked as base "Dirt Patch" on site sketch) - owner reports this is septic tank, soil is not fill, just remixed soil from the yard. <u>DS JM 6-30-03</u>
